REPORT NUMBER: 217-MGA-03-001

**SAFETY COMPLIANCE TESTING FOR  
FMVSS NO. 217  
SCHOOL BUS EMERGENCY EXITS AND WINDOW  
RETENTION AND RELEASE**

**2003 American Transportation Corporation  
IC3S530 School Bus  
NHTSA No.: C30902**

**PREPARED BY:  
MGA RESEARCH CORPORATION  
5000 WARREN ROAD  
BURLINGTON, WI 53105**

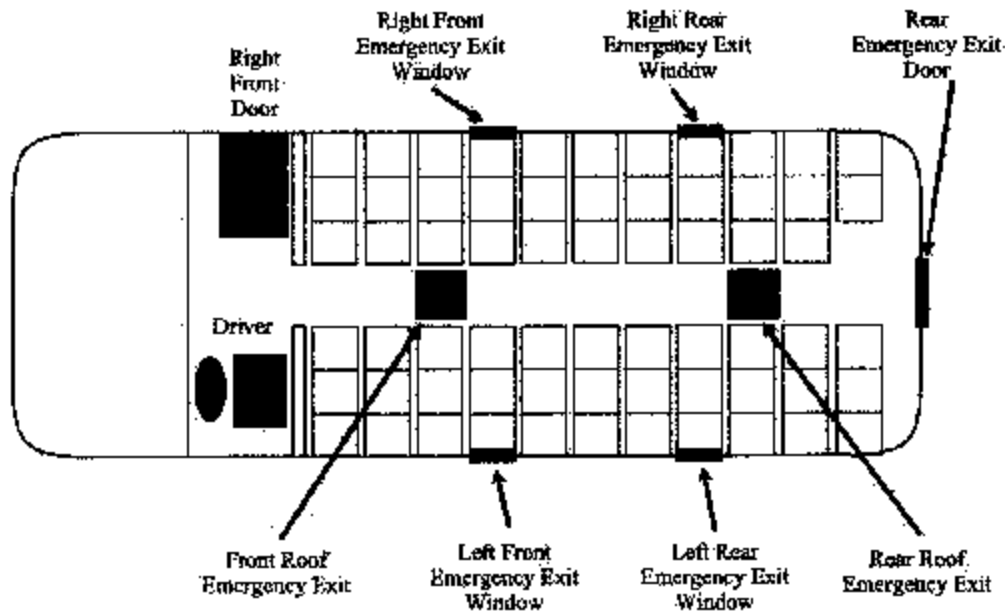
Height (mm)	Width (mm)
1	Left Front Exit Window	485	595
2	Left Rear Exit Window	485	595
3	Right Front Exit Window	485	595
4	Right Rear Exit Window	485	595
5	Rear Exit Door	1313	920
6	Roof Exit – Front	513	565
7	Roof Exit – Rear	513	565

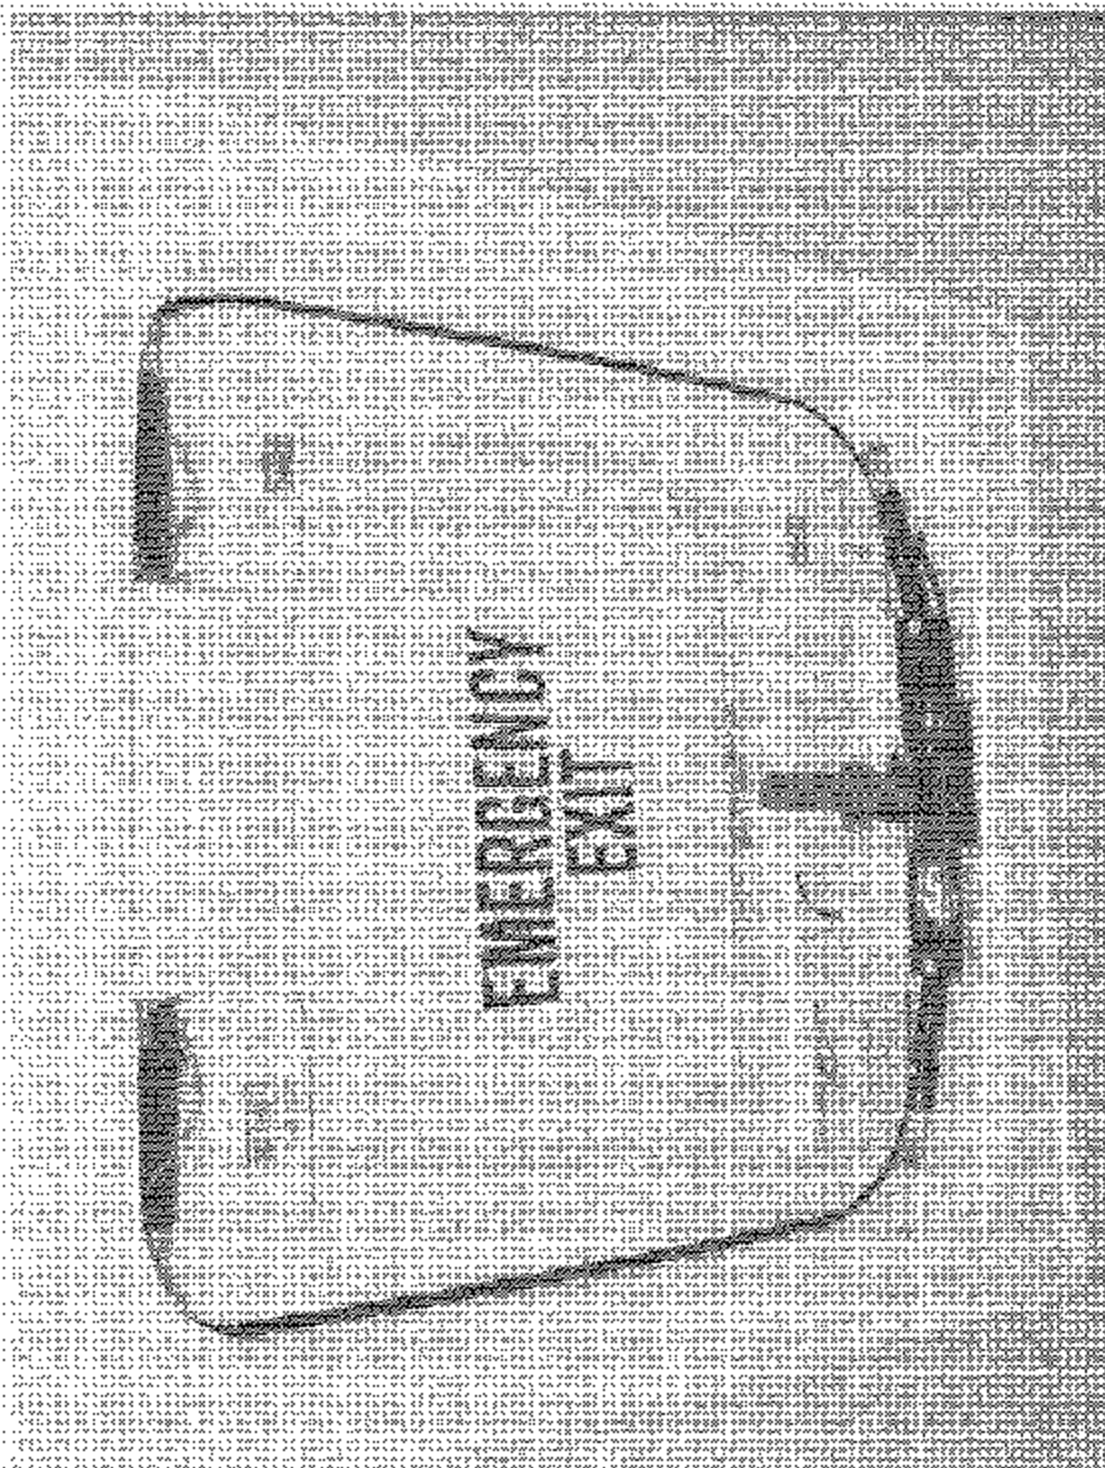
Test Vehicle: 2004 A/C Cadillac School Bus  
Photograph 17:  
Front Roof Hatch Identification Inside View  
Procedure: FMVSS 217  
NHTSA No.: C36502

<sup>(1)</sup> The retroreflective tape outlining the exterior of the front and rear roof hatch opening is silver in color. FMVSS 217 requires the retroreflective tape color to be either white, red, or yellow in color for emergency exits.

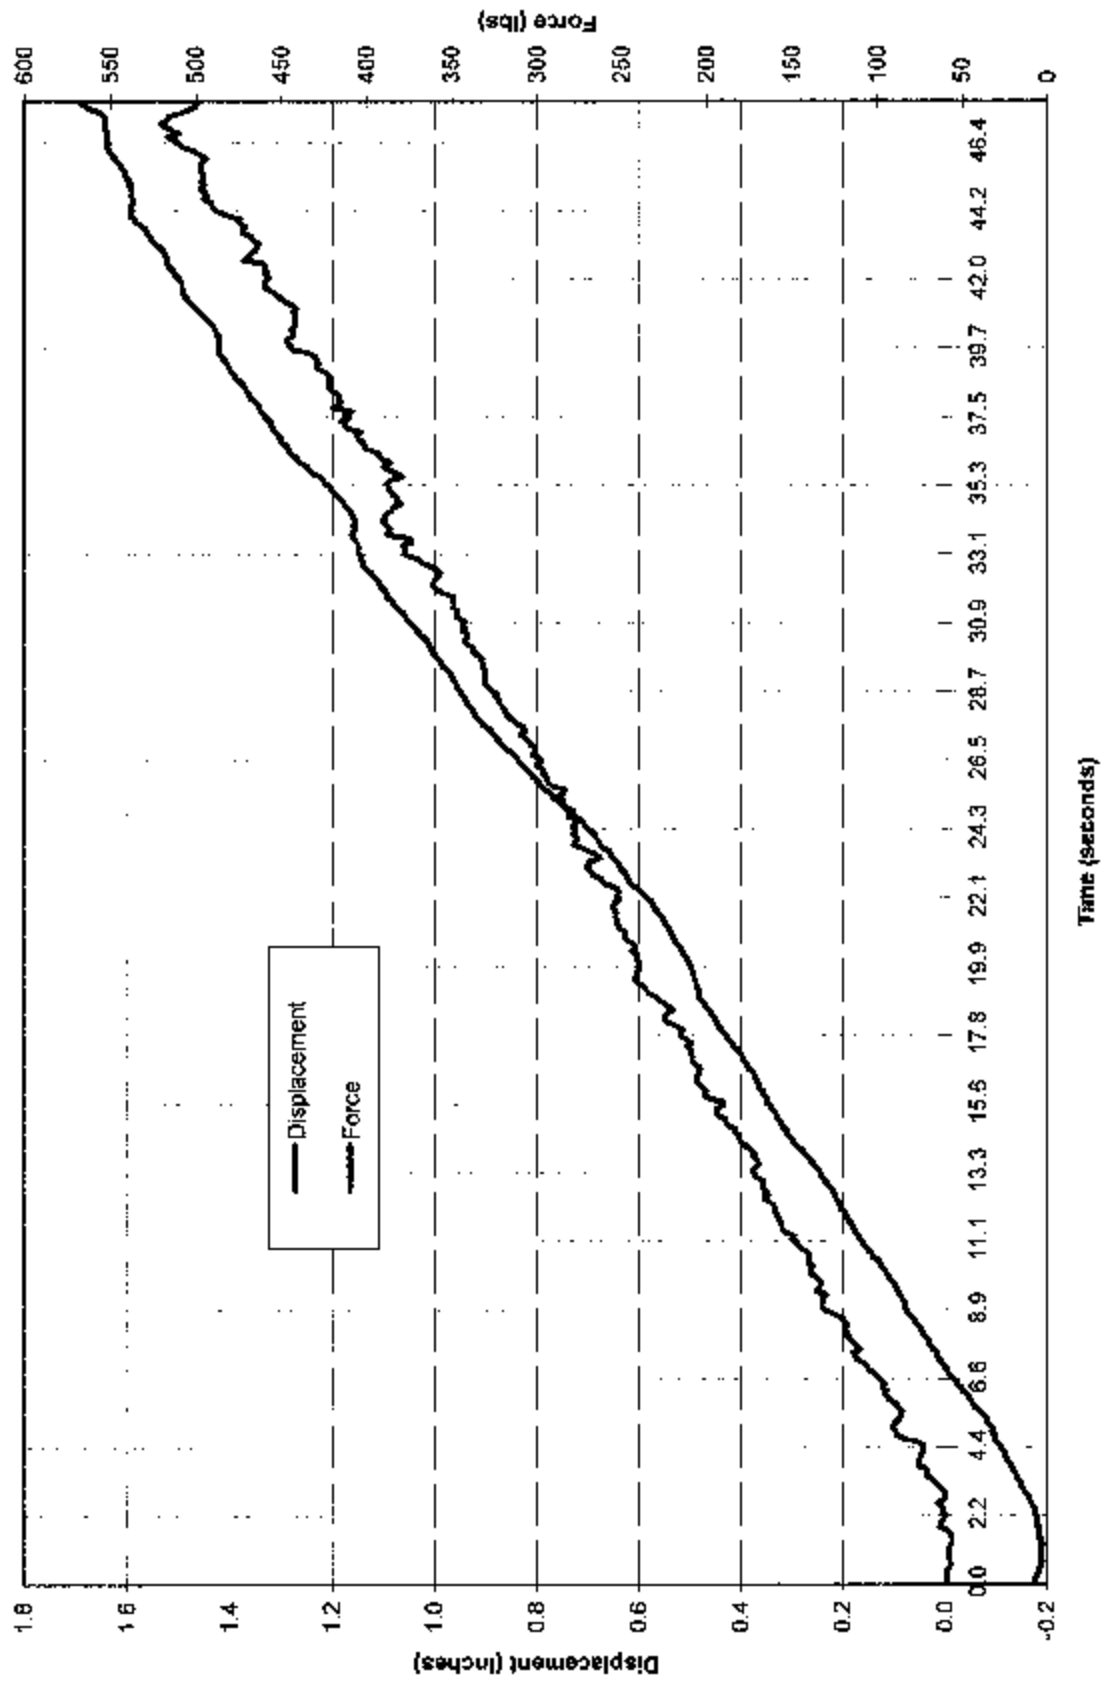
FMVSS 217 NHTSA No: C30902  
 ATC IC3S530 Right Front Window - Upper Pane

<sup>(1)</sup> Window reached the deflection requirement of S.5.1
